WESCO Restoration and Renovation The Morris Civic Auditorium Fountain

Project Overview

Owner: City of South Bend
Location: South Bend, Indiana
Date: 2001

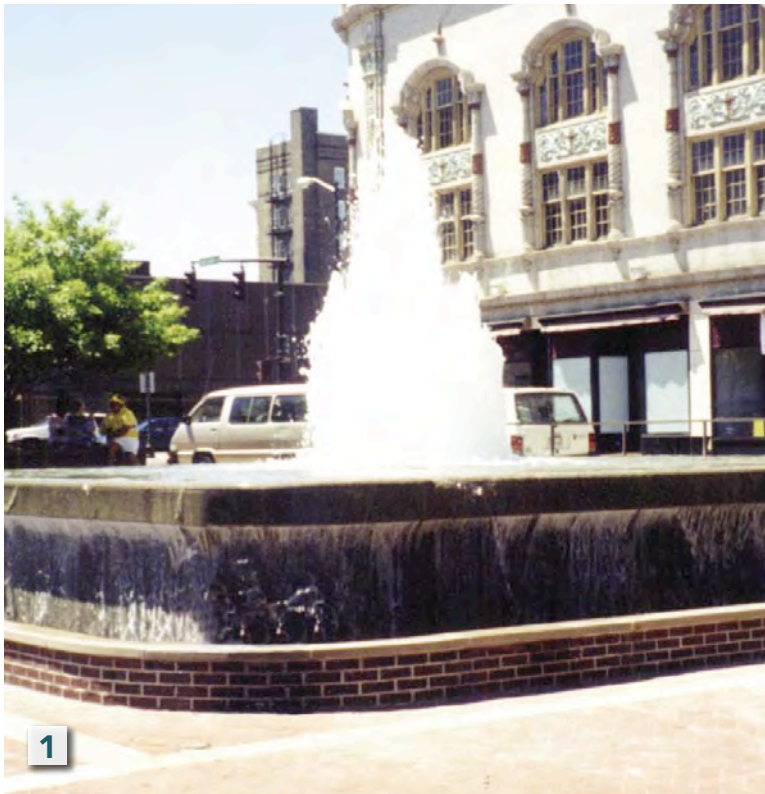
1

1. The Morris Center Auditorium fountain fully restored.
2. The original fountain shortly before restoration.
3. A sample of the debris that collected in the lower basin.

WESCO Fountains, based on their functional renovation solution, won over the city, and the work began. To address the trash and debris issue, WESCO constructed a short retaining wall that encircled the feature's lower pool, preventing anything to blow directly into the water. New nozzles were employed which created a better effect and addressed the windy open area. Brand new pumping systems were installed to better handle the feature nozzles and the water flow of the weirs. Finally, all new electrical, filtration and control systems were installed within the existing equipment room to now fully restore this feature for the City of South Bend.

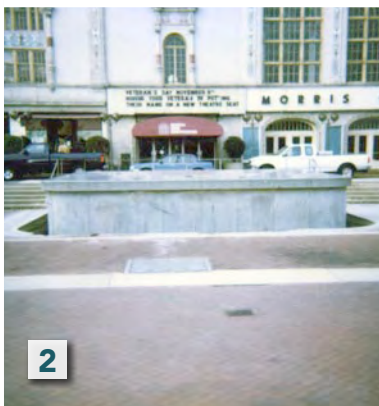
2

The City fountain in front of The Morris Civic Auditorium had gone through many changes over the years. The original design included a sculptural element in the center with nozzles that sprayed onto the sculpture. That element had been removed, leaving the nozzles to freely spray into the air - an effect not originally intended.

Further more, the original fountain had the unfortunate design of being in an open, wind blown area, with a lower pool at ground level designed to hold the water that flowed over the upper weir. Both of those elements led to problematic maintenance issue when the wind caused trash and debris to fill the lower pool, creating suction issues and damage - inhibiting the proper function of the feature.
